# Manhole Inspection Summary

Manhole # S47M\_\_005MH

Insp Date: **10/6/08 9:18 AM**

**Location** Address: **2337-5 boston st.**

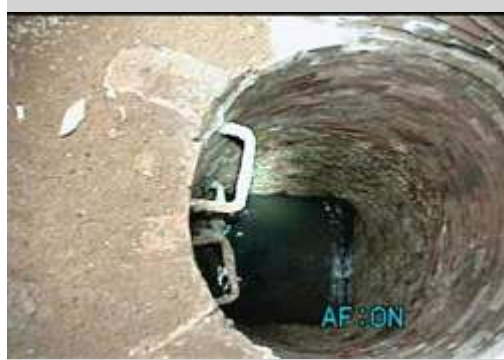
Top View

Condition: ☐ Sound ☐ Cracked ☐ Root Intrusion ☐ Loose Brick ☒ **Deteriorated**

**Steps** Count: **8** Missing: **0** ☒ **Corroded**
